In August 2003, SNET and NGI carried out a common field excursion in Western Norway to study examples of protective structures constructed for protecting infrastructure (mainly living houses) from being hit by debris flows and snow avalanches. This report sums up the field excursion.

## 1 EXCURSION

A two day field excursion was planned for Manuel Diaz and Walter Hernandez, both from SNET (Servisio Nacional de Estudios Territoriales), to show some of the Norwegian mitigations against debris flow and avalanches.

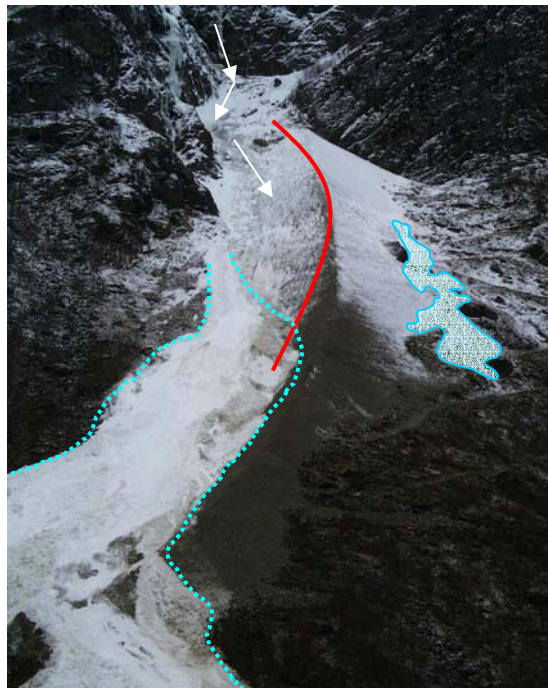
*Photo no 1. Snow avalanche deposits along the deflecting dam in Langageiti (1999)*

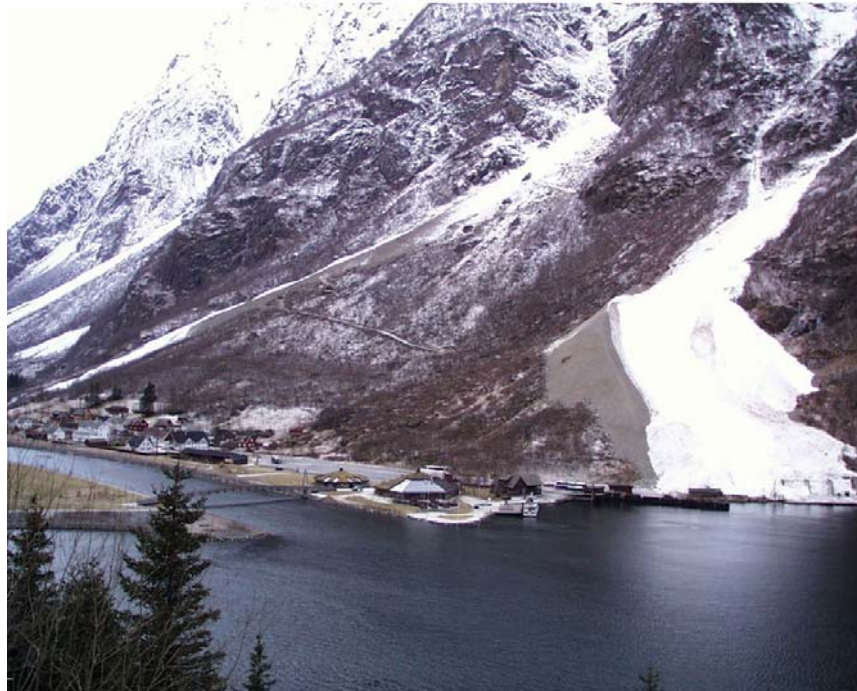
*Photo no 2. Two large avalanches were deflected by the Nautagrovi dam (1998-1999)*

Two wet avalanches hit the dam in the winter of 1998-99 (Photo no 2) at estimated velocities of 20 m/s (less than the design velocity  $v_T=25$  m/s) and with estimated volumes of 100 000 m<sup>3</sup> in both events. The observed run-up heights were measured to  $r_{obs} \approx 7$  m at both occasions. The calculated run-up heights with  $v_T=20$  m/s (corresponding to  $\mu=0.3$  and  $M/D=200$  m) are  $r_{cal}=8.0$  m, 5.8 m, and 5.2 m for  $k=1.0$ , 0.5, and 0.0, respectively.

In the upper part of the dam a small portion of the first avalanche had a larger angle of incidence of  $48^\circ$ . This portion also overtopped the dam. The calculated run-up height for  $k=1.0$  and is  $r_{cal}=13$  m. This is obviously the critical part of the dam, but lack of loose deposits and steep terrain inclination prevented further expansion.

The second avalanche ran on top of the deposits of the first one. The avalanche reached the top of the dam and followed just beneath the dam crown all the way down to the sea. This is probably because the avalanche is wide ( $\sim 100$  m) and is forced towards the dam over a long distance. The contour lines of the adjusted terrain on the upper side of the dam are perpendicular to the dam centre line. This will enhance the leading effect of the dam.

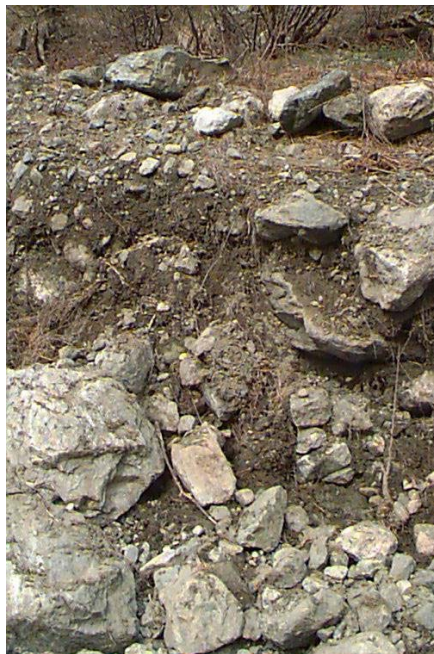
The natural soil deposits in the area of the two dams display a large amount of coarse material, Photo no 3. Soil samples of the finer fractions of the natural deposits (rocks and boulders excluded) were taken in a total of four shafts

Grain size distribution curves from all of the samples show that the finer fractions of the natural deposits in general can be described as a sandy, gravelly material. In addition, there is a slight tendency to more fines with depth in some of the shafts, and also more fines are found in the upper sections of the scree in which the dams are constructed. The percentage of fines less than 0.075 mm is less than 10 – 15 % for most of the samples, but does in some cases reach to about 25 %.

*Photo no 3. Natural soil deposit shows large amount of coarse material*

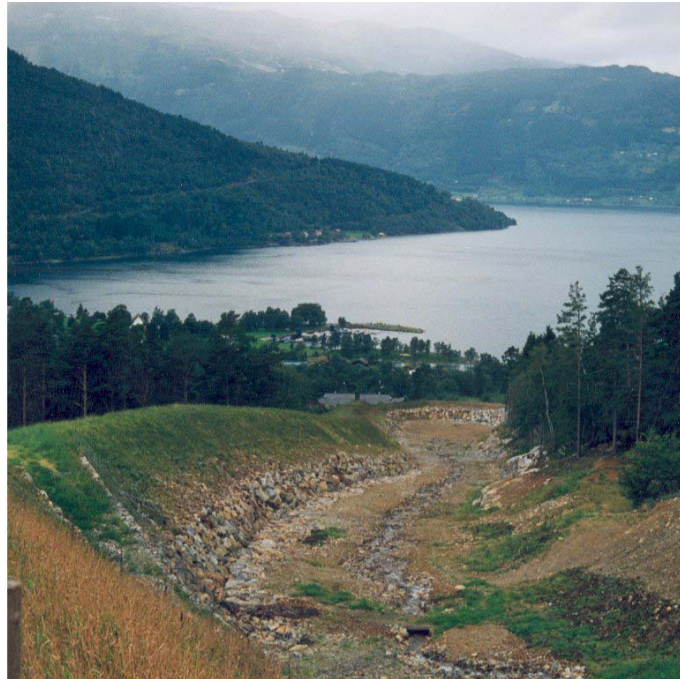
*Photo no 4. A 5 m – 10 m high channel dam was built to prevent housing areas in the central part of Kinsarvik to be hit by debris flows.*

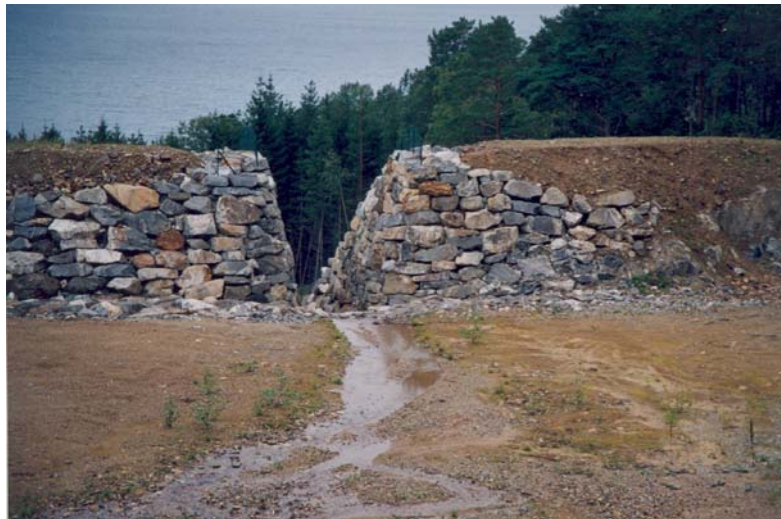
*Photo no 5. In the lower part of the channel area a wider accumulation basin is built, with an opening in the middle to allow water drainage. This also permits accumulated masses to be eroded out of the accumulation area. We expect some maintenance after each debris flow. A road over the dam permits access to the channel area for maintenance.*

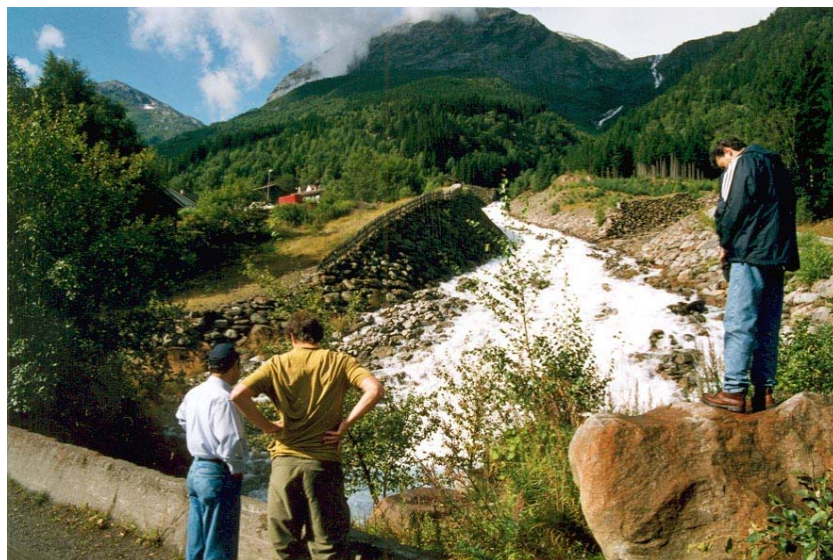
The main dam at Eitrheim is 350 m long and 8m - 10 m high. The dry rock wall on the side facing the river is due to expected erosion from avalanches. The excavated channel and elevated dam was built by moving 55 000 m<sup>3</sup> of loose deposits.

Photo no 6. View of the deflecting dam at Eitrheim seen from the road

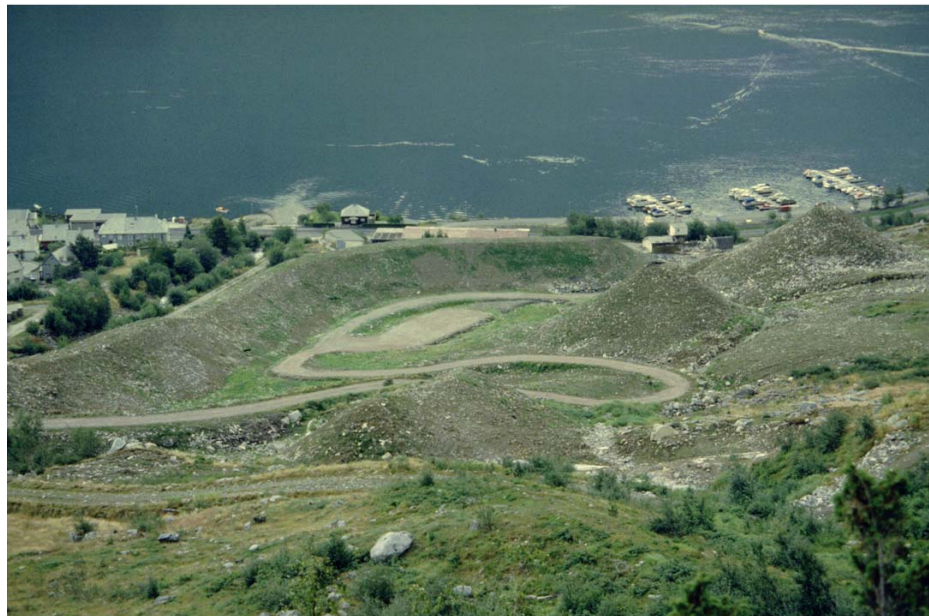
A deflecting dam and breaking mounds have been built to secure the housing areas on both sides of the Tokheim River. The dimensions are based on calculations of velocity and volume on the avalanche. The effect of the mitigation work is questioned, due to several avalanche incidents during a single winter season.

Photo no 7. View of the mitigations at Egne Hjem securing the housing area and the road against avalanches

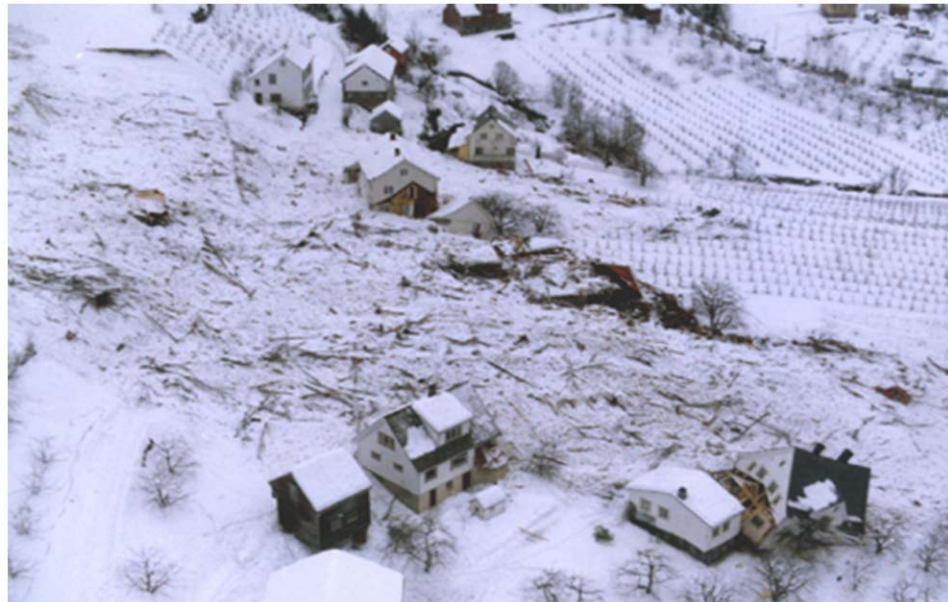
A major snow avalanche hit the farms at Bleie, municipality of Ullensvang, January 27 1994. 3 dwelling houses were completely destroyed, and one house severely damaged. One barn and three other buildings were either damaged or destroyed. The written history of the Bleie farms dates back to 1293 a.d. In this period no avalanches are known to have hit the farms or having been nearby the farms. The return period for the avalanche was calculated to 800-1000 years, based on historic evidence and climatic records. The horizontal length of the avalanche was 3600 m. Based on velocity and volume calculations different methods of protections were planned.

*Photo no 8. The 1994 snow avalanche hit three farms at Bleie and destroyed some of the houses*

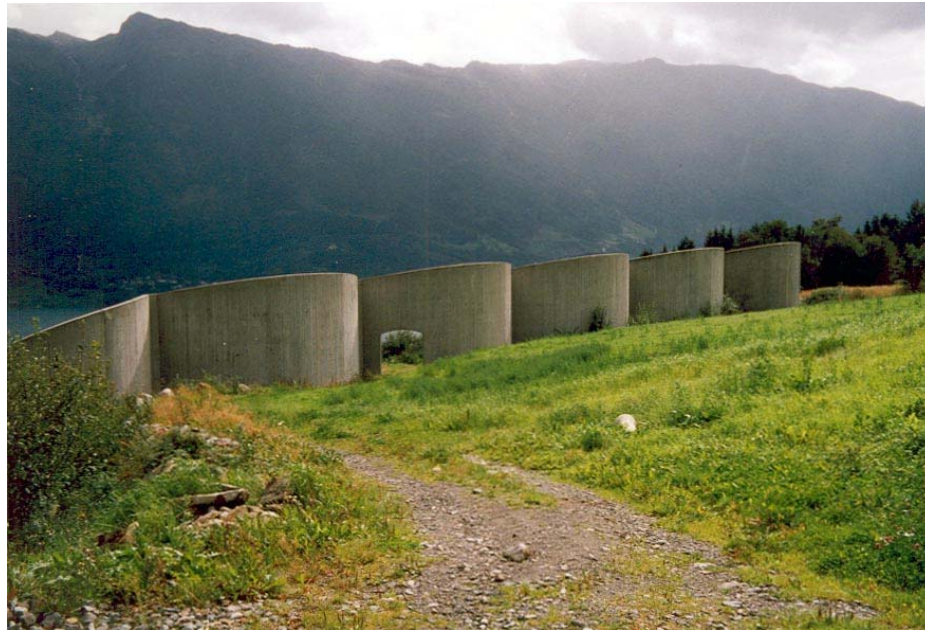
*Photo no 9. View of the catching wall at Reiseter*

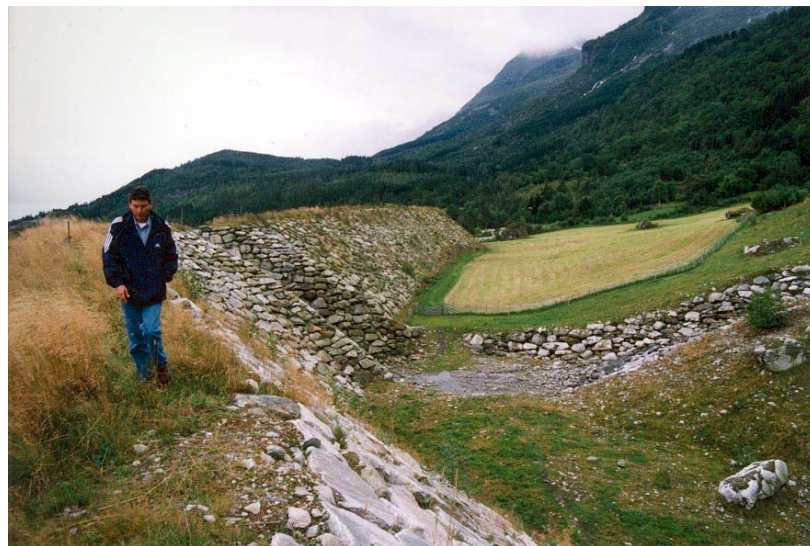
Figure 6 show the extent of the hazard zone related to the demands in the legislations and building codes. The alternative that was chosen and built, see photo no 10, is a 10 m – 12 m high and approximately 350 m long catching dam.

Photo no 10. Catching dam at Aga

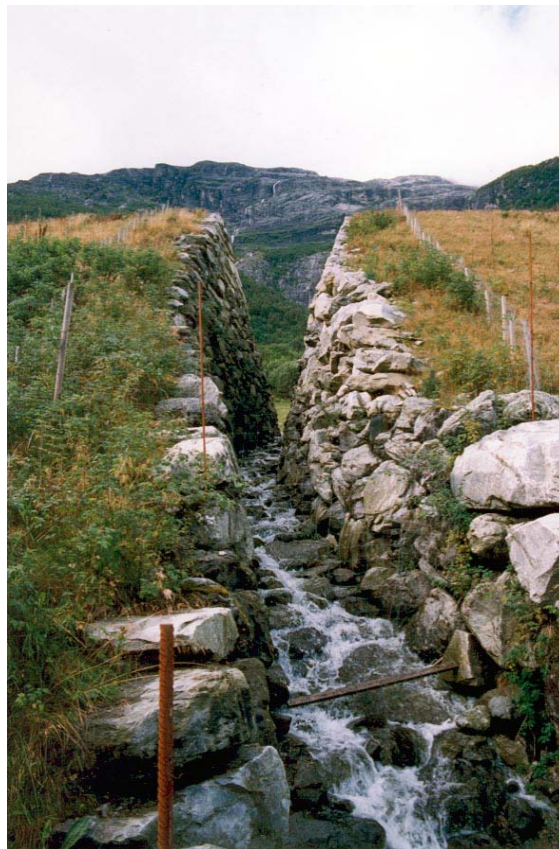
*Photo no 11. Detail of the opening in the catching dam*
