## Summary

This report summarises the experience gained from the first full year operation of the two stations. The report also includes some of the data that has been received.

| <b>Dokumenttittel/Document title</b><br>Protective measures to reduce the landslide risk in El Salvador.<br>Rainfall measurements Operational Experience - Summary<br><b>Prosjektleder/Project Manager</b><br>Oddvar Kjekstad<br><b>Utarbeidet av/Prepared by</b><br>Klaus Tronstad | | <b>Distribusjon/Distribution</b><br><input type="checkbox"/> <b>Fri/Unlimited</b><br><input checked="" type="checkbox"/> <b>Begrenset/Limited</b><br><input type="checkbox"/> <b>Ingen/None</b> |

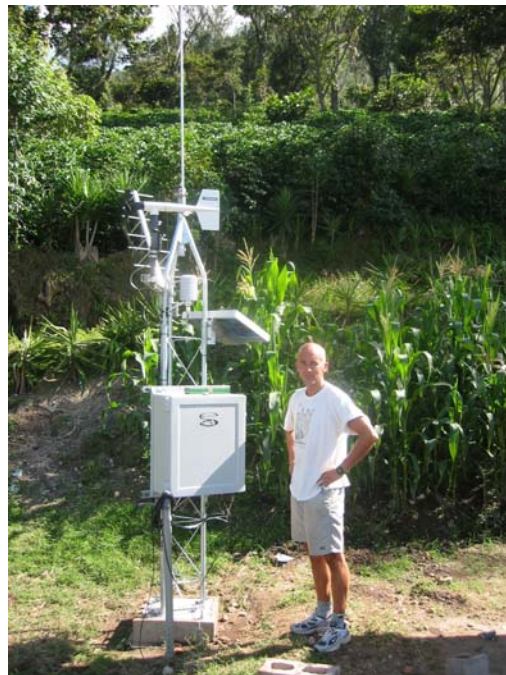
*Figure 1 Rainfall station (San Vicente)*

With respect to the San Vicente station, it was working very well until February 2003 when the signal was lost. After several field visits and after several tries during March, it was determined that the transmitter was not working properly and it was the cause of the problem. After several consults with Sutron in April and May, the damaged part was sent to the factory for warranty repair. After a couple of months in Sutron, the transmitter was received back in SNET at the end of August 2003 and it was installed in middle September. Since then, the station has been in operation again.

We have not received any report from Sutron regarding the warranty repair that was performed on the data recorder from San Vicente. In general we feel that a repair period of several months is not acceptable under any circumstances.

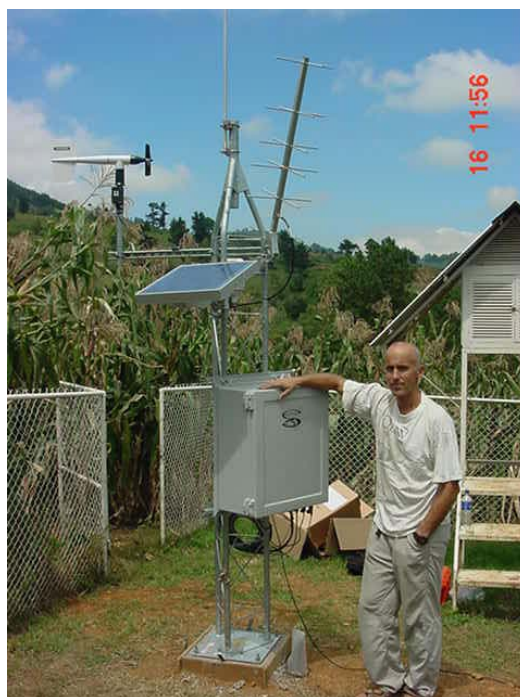
*Figure 2 Rainfall station (Las Pilas)*

The Las Pilas station has been working almost continuously since the recording started in October 2002. Only small problems due to battery failure have been experienced. These battery problems were successfully repaired with a couple of visits to the station along the year.

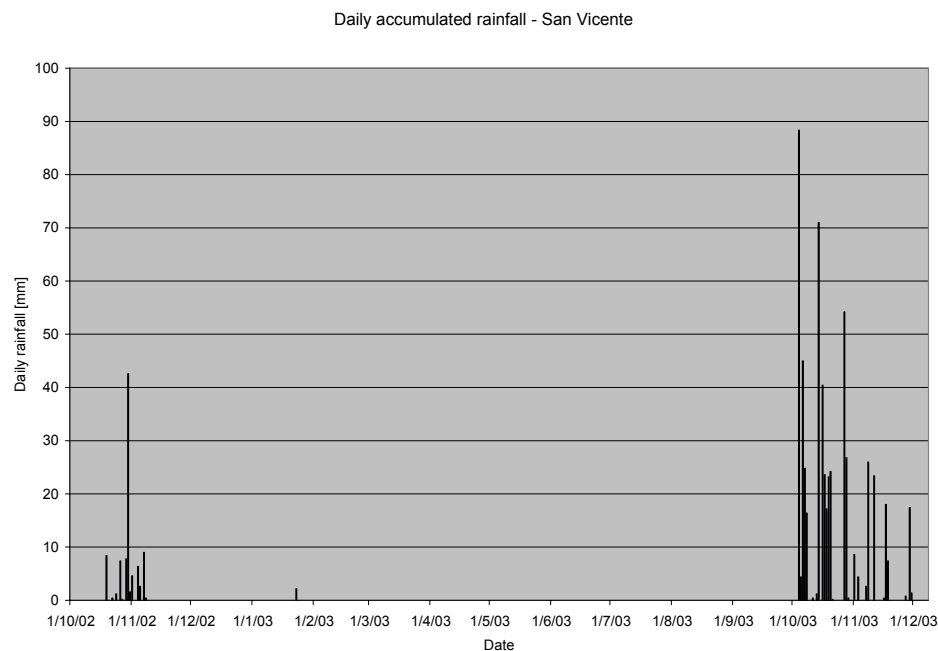
*Figure 6 Daily rainfall measurements – San Vicente station*

Due to a technical problem with the data logger at San Vicente no data was recorded between February and October in 2003. At Las Pilas, the measurements show that the precipitation is close to zero in the period November 2002 to May 2003, except for a some rainfall in end of March.

In figure 5 and 6 the measured precipitation from the date of installation until December 2003 is presented for both stations. Due to transmission failure data from the San Vicente station is missing for the major rain periods in 2003.
