In August 2003, SNET and NGI carried out a common field excursion in Western Norway to study examples of protective structures constructed for protecting infrastructure (mainly living houses) from being hit by debris flows and snow avalanches. This report sums up the field excursion.

## 1 EXCURSION

A two day field excursion was planned for Manuel Diaz and Walter Hernandez, both from SNET (Servisio Nacional de Estudios Territoriales), to show some of the Norwegian mitigations against debris flow and avalanches.

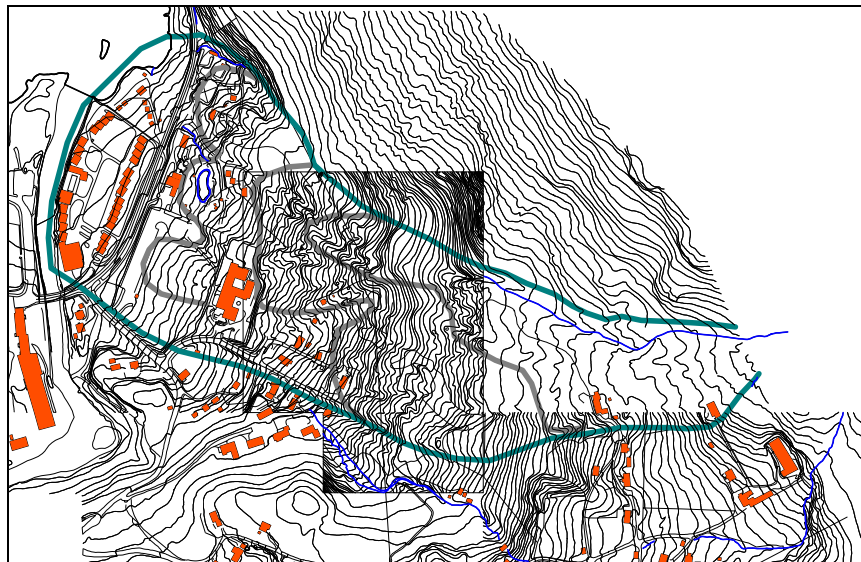
In Kinsarvik, in the municipality of Ullensvang, several houses and an elder centre were found to be situated within reach of debris flow. Five large debris flows has hit the area the last 400 years. This have been historically documented, but not remembered by officials when housing areas was planned.

*Figure no 1. Map of central part of Kinsarvik showing the maximum extent of debris flow. Three zones within the debris flow boundary indicate levels of coarser material.*

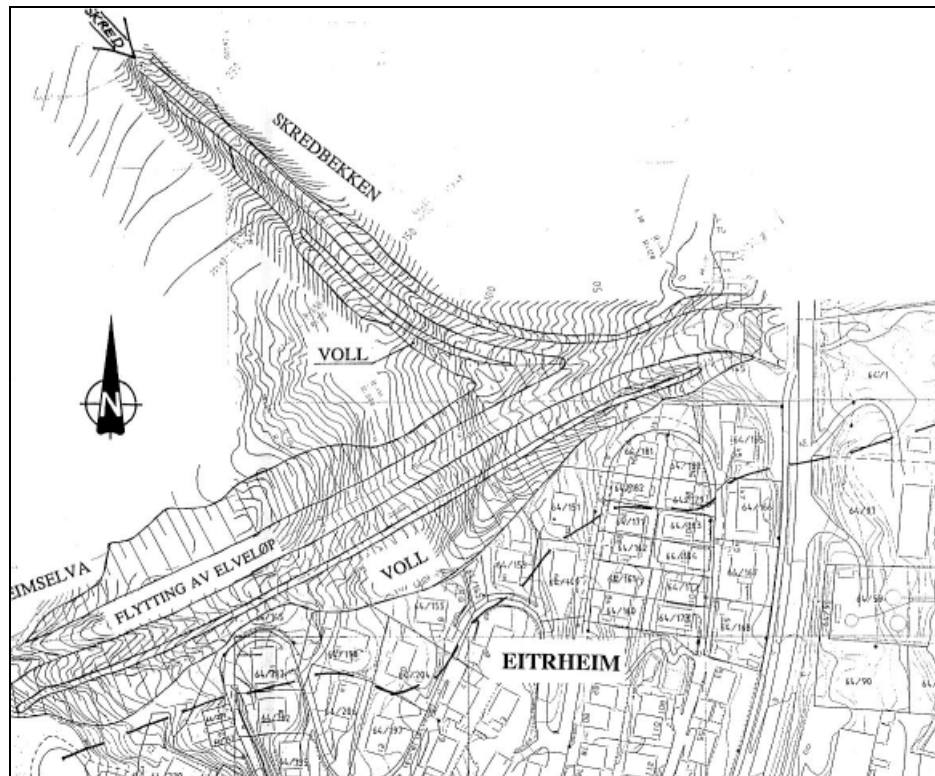
The main dam at Eitrheim is 350 m long and 8m - 10 m high. The dry rock wall on the side facing the river is due to expected erosion from avalanches. The excavated channel and elevated dam was built by moving 55 000 m<sup>3</sup> of loose deposits.

Figure no 2. Map showing the channel leading slides, water and avalanches along the side of a housing area at Eitrheim

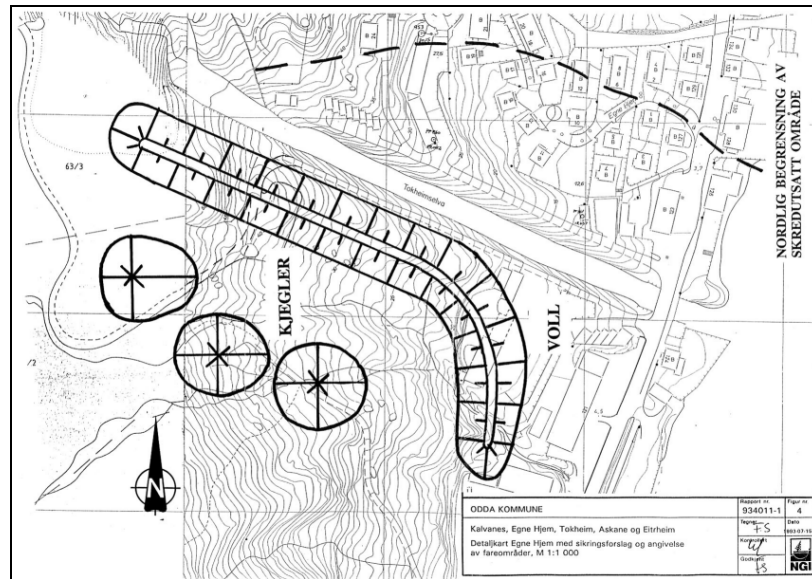
A deflecting dam and breaking mounds have been built to secure the housing areas on both sides of the Tokheim River. The dimensions are based on calculations of velocity and volume on the avalanche. The effect of the mitigation work is questioned, due to several avalanche incidents during a single winter season.

Figure no 3. Sketch of the deflecting dam and earth mounds at Egne Hjem

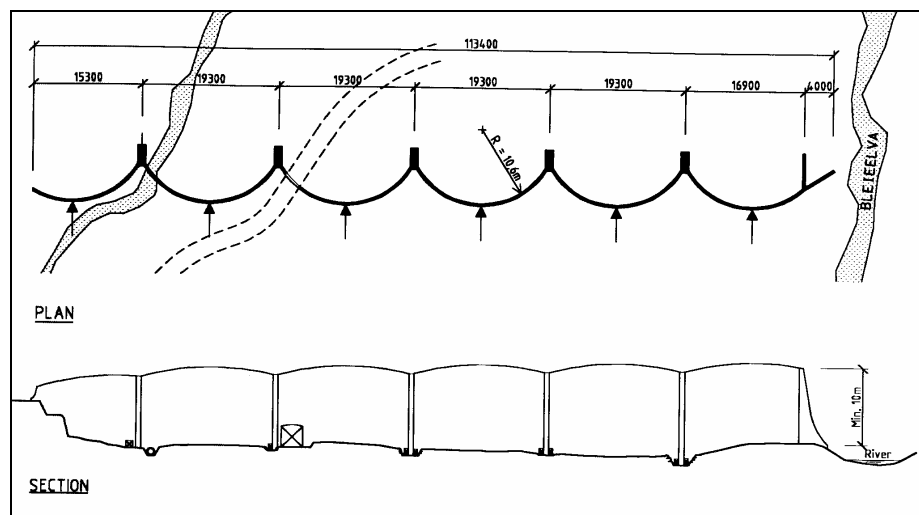
Figure no 4. The wall consists of five-and-a-half half-cylindrical shells monolithically connected to form the 113.4 m long wall

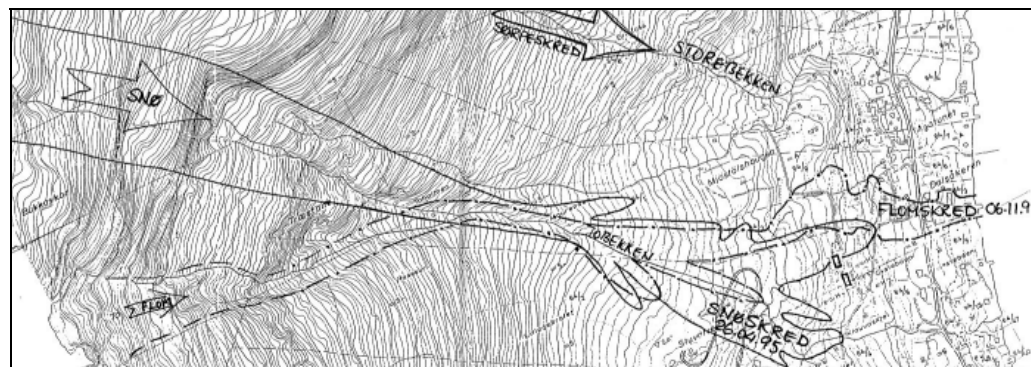
The farm houses at Aga can be reached by debris flow, avalanches and slush flow (water and snow mixture). We expect that the most endangered houses can be reached once each 50 – 100 years on the average. Figure no 5 show the known boundaries of a debris flow in 1992.

*Figure no5. Extent of debris flow in 1992*

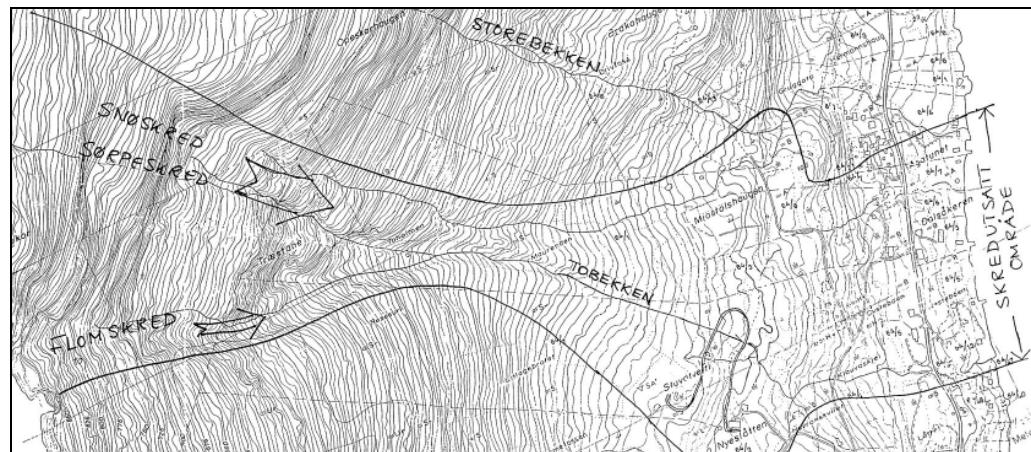
Figure 6 show the extent of the hazard zone related to the demands in the legislations and building codes. The alternative that was chosen and built, see photo no 10, is a 10 m – 12 m high and approximately 350 m long catching dam.

Figure no 6. Hazard zone at Aga
