## Summary

This report summarises the experience gained from the first full year operation of the two stations. The report also includes some of the data that has been received.

| <b>Dokumenttittel/Document title</b><br>Protective measures to reduce the landslide risk in El Salvador.<br>Rainfall measurements Operational Experience - Summary<br><b>Prosjektleder/Project Manager</b><br>Oddvar Kjekstad<br><b>Utarbeidet av/Prepared by</b><br>Klaus Tronstad | | <b>Distribusjon/Distribution</b><br><input type="checkbox"/> <b>Fri/Unlimited</b><br><input checked="" type="checkbox"/> <b>Begrenset/Limited</b><br><input type="checkbox"/> <b>Ingen/None</b> |

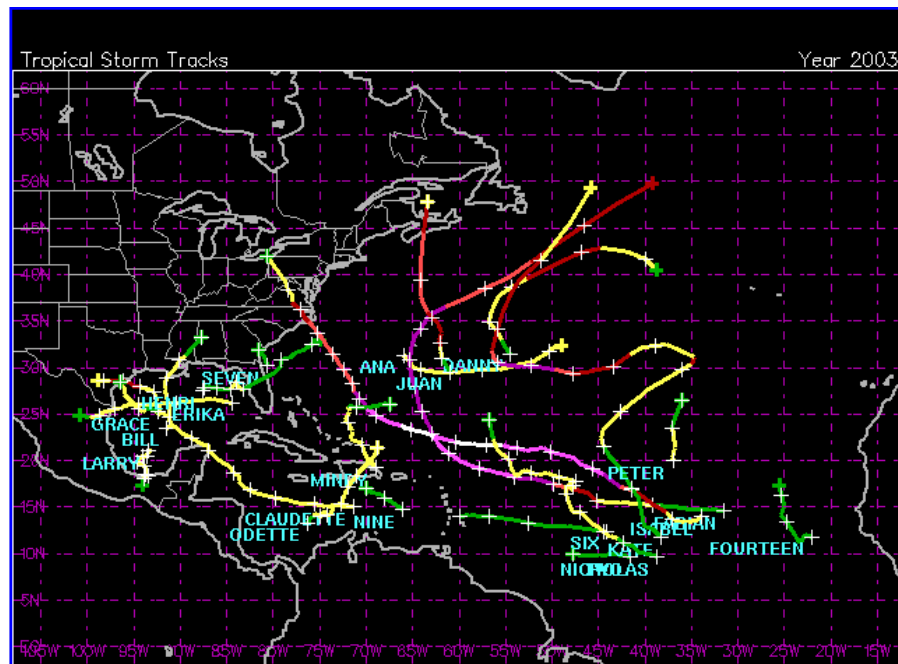
This is the first complete measurement for a full rainy season. There have been no hurricanes or severe tropical storms in El Salvador in this period according to the tropical cyclone tracks presented in figure 3.

Figure 3 Tropical cyclone tracks for 2003

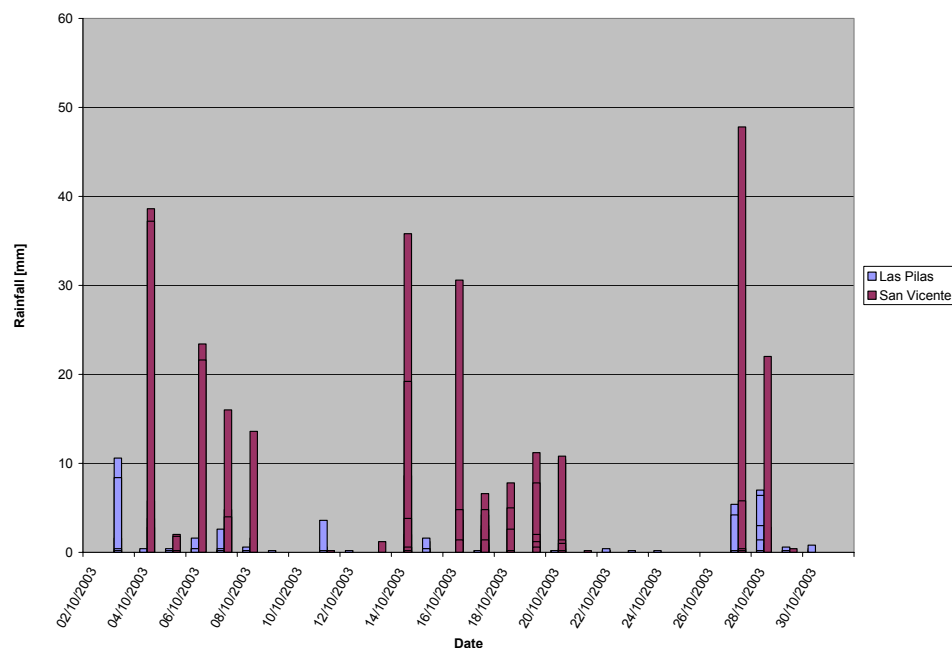
The following plot (figure 4) shows hourly rainfall measurements from the two meteorological stations in October 2003. The San Vicente area is clearly more exposed to heavy rainfall compared to the Las Pilas area.

Figure 4 Hourly rainfall measurement in October 2003.

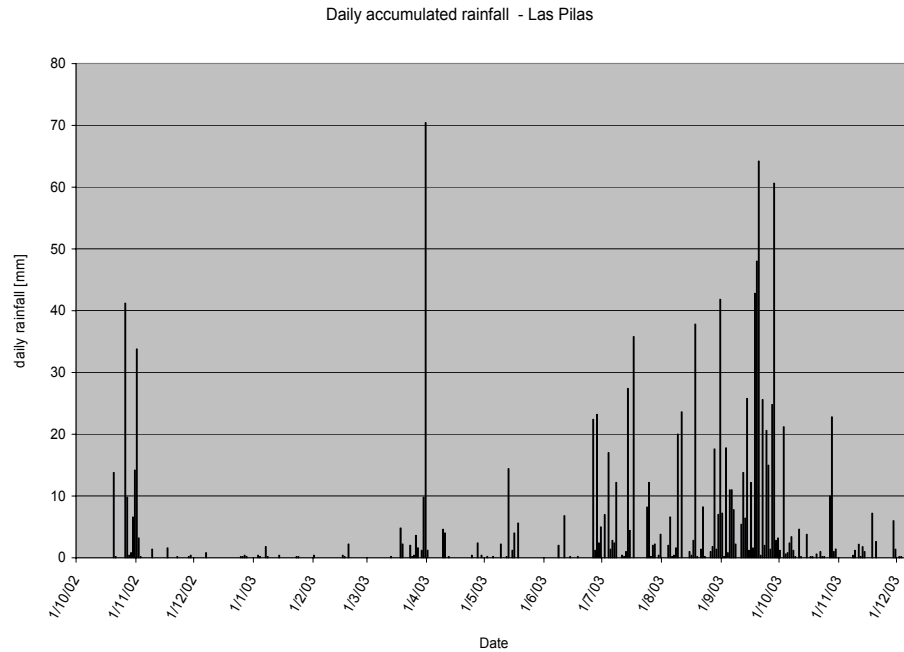
In figure 5 and 6 the measured precipitation from the date of installation until December 2003 is presented for both stations. Due to transmission failure data from the San Vicente station is missing for the major rain periods in 2003.

*Figure 5 Daily rainfall measurements – Las Pilas station*
